Manhole Inspection Summary

Manhole # S01UU1022MH

Insp Date: **8/11/06 9:27 AM**

Location Address: **3701 Menlo Dr**

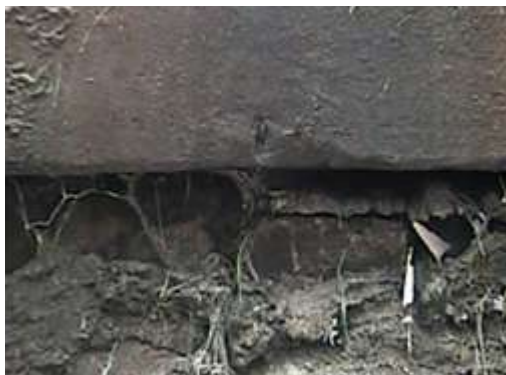
adjustment

☒ Exists Material: **Brick and Concrete** ☐ Parged Height: **4** (in.)

Condition: ☐ Sound ☐ Cracked ☐ Root Intrusion ☐ Loose Brick ☒ **Deteriorated**

Infiltration: ☐ None ☒ **Joint** ☐ Cracks ☒ **Mortar** ☐ Roots ☐ Wall

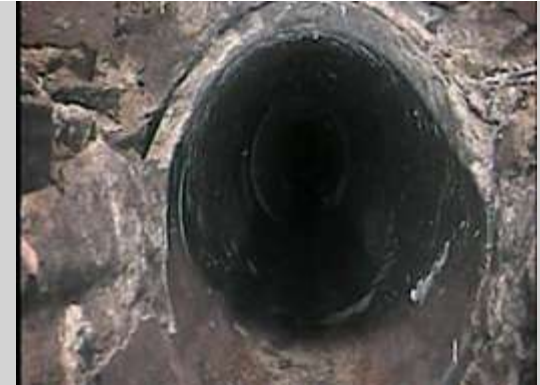
8 in. Circular Gravity Sewer Pipe Out @ 12 O'Clock

Pipe Material: **Clay** ☐ Pipe Lined

Invert Depth: **6.10** (ft.) Flow Characteristics: **None**

Deposits: ☒ None ☐ Mud ☐ Sludge ☐ Debris ☐ Grease

Infiltration: **None** Pipe Seal Cond: **Sound**

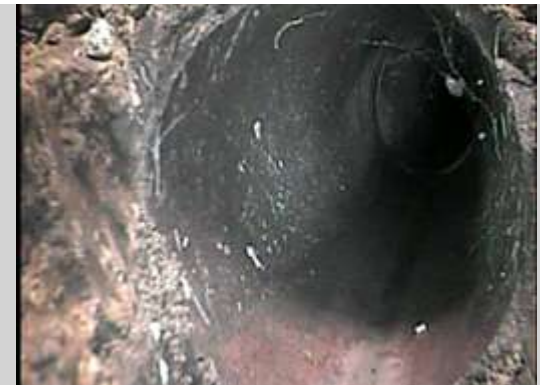
6 in. Circular Gravity Sewer Pipe In @ 7 O'Clock

Pipe Material: **Clay** ☐ Pipe Lined

Invert Depth: **5.85** (ft.) Flow Characteristics: **None**

Deposits: ☒ None ☐ Mud ☐ Sludge ☐ Debris ☐ Grease

Infiltration: **None** Pipe Seal Cond: **Sound**

Connects To: **House connection / Service line**
